INSPECTOR GENERAL  
DEPARTMENT OF DEFENSE  
400 ARMY NAVY DRIVE  
ARLINGTON, VIRGINIA 22202-2884

May 21, 1991

SUBJECT: Report on the Audit of Performance and Reliability of  
Cobra Helicopter Rotor Blades (Report No. 91-082)

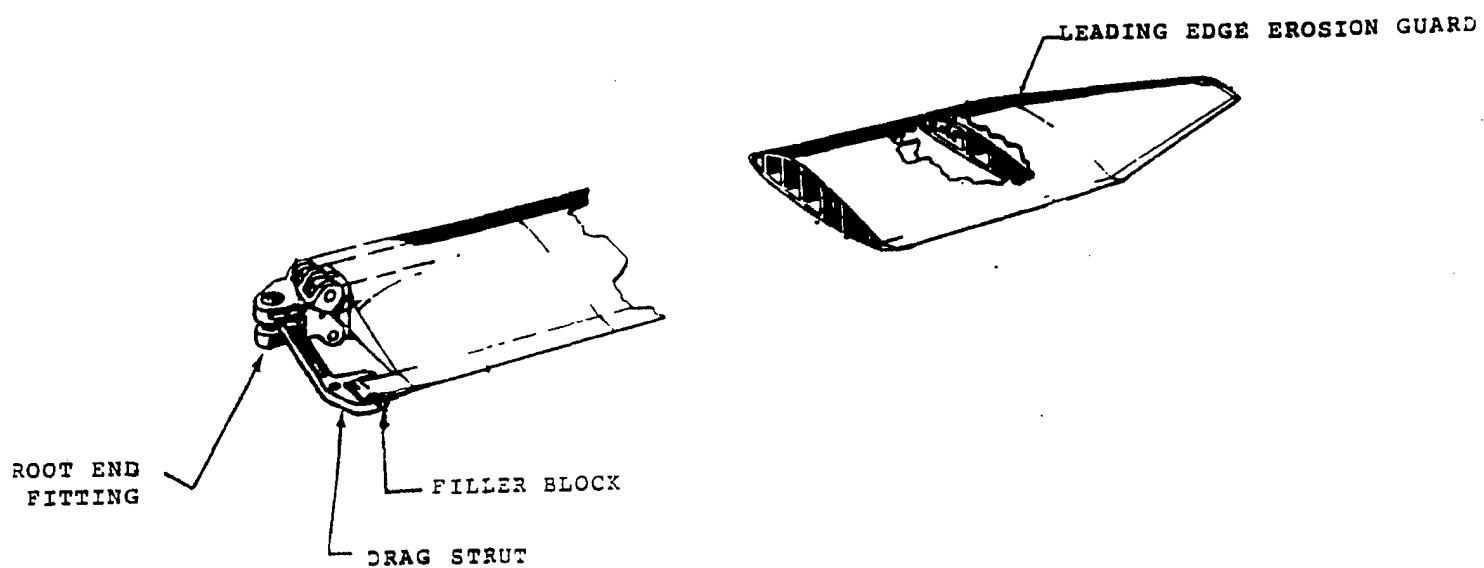
ENCLOSURE 1

The K747 blade that is used as the main rotor blade on the AH-1 Cobra Helicopter has had performance and reliability problems. The blade's most serious performance and reliability problems included cracking in the root end fitting and erosion of the blade's leading edge (see Enclosure 1). However, the Government and the blade's manufacturer identified and corrected the problems. The actions appeared to be complete and satisfactory.

The cracks and voids in the blade discovered by Sharpe personnel did not appear to be a problem. Sharpe Army Depot's Nondestructive Evaluation Team discovered cracks and voids in the blade drag strut attaching point (see Enclosure 1) by X-ray imaging in February 1989. Sharpe submitted six Quality Deficiency Reports addressing the deficiencies to the Army Aviation Systems Command. The Army Aviation Systems Command's engineering department replied to Sharpe's deficiency reports in February 1990 stating that the cracks and voids that Sharpe identified were located within the filler block of the blade and that cracks and voids in this area were acceptable. The Army Aviation Systems Command's conclusion was based on an engineering evaluation that the contractor performed and the Government's plant representative monitored. Additionally, in June 1990, the Army Materiel Command informally requested that engineering
